## Contents

## Cisco\_IOS\_Voice\_Troubleshooting\_and\_Monitoring\_--\_Fax\_Relay

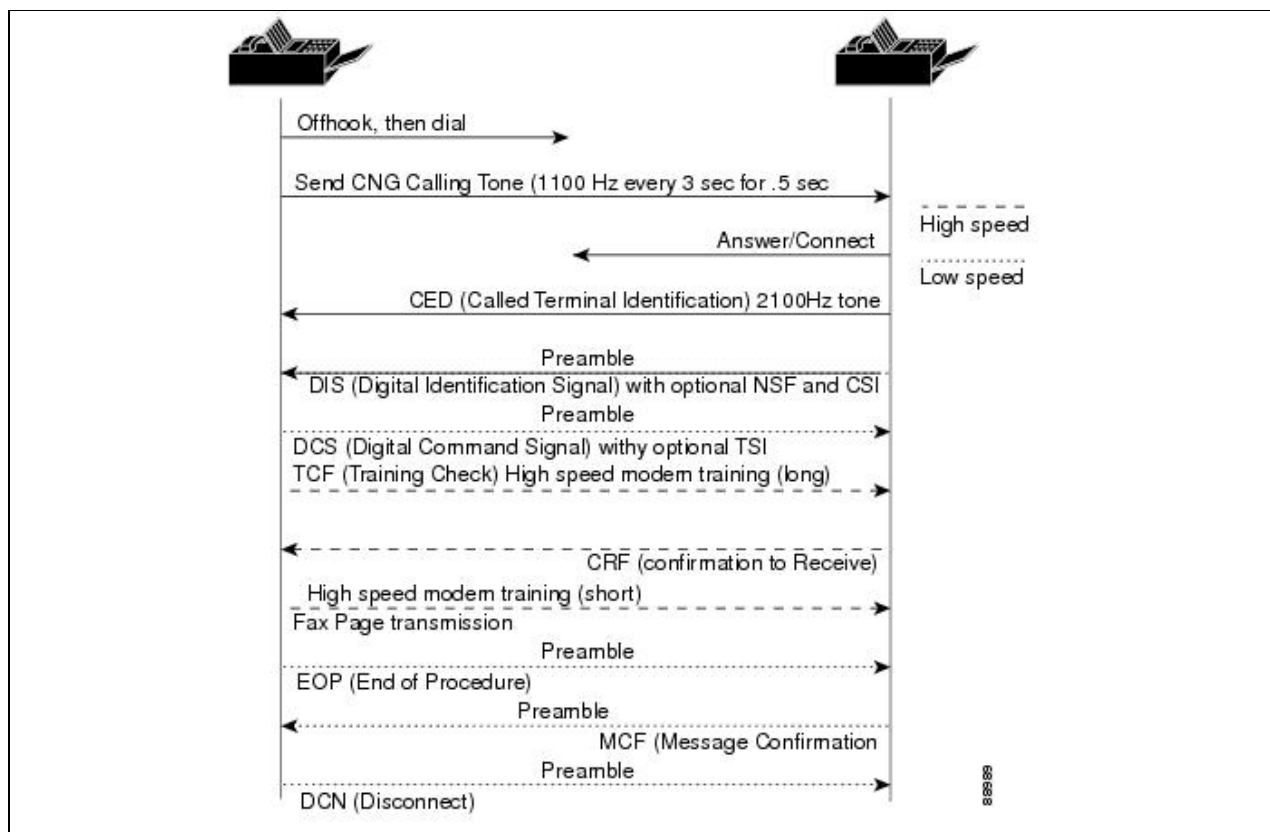
Figure: T.30 Transactions

The debugs can be difficult to understand if you are not familiar with the messaging that occurs during a typical fax transmission. [Figure: T.30 Transactions](#) is a graphical representation of the basic T.30 transactions that occur for a single page fax transmission.

Describing the details of these transactions is beyond the scope of this document, but listed below are definitions of the basic transactions that are seen during fax relay. The list is alphabetical for quick reference and includes messages that you are likely to see when you are debugging Cisco fax relay. For more in-depth information on this messaging or for information on messages that are not listed below, see the T.30 specification.

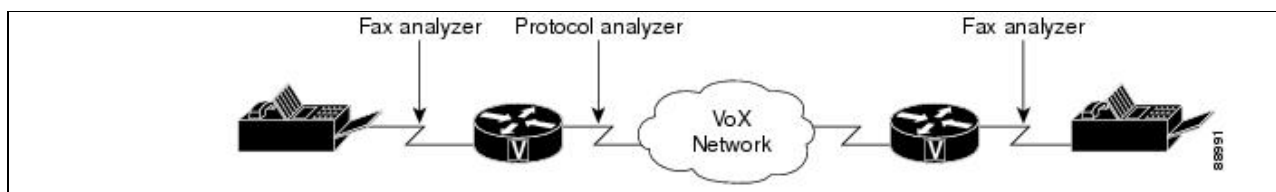
**Figure: Test Equipment Placement**

The ability to resolve a complex problem sometimes requires using a combination of equipment—an analyzer to capture the fax traffic at each fax machine and a protocol analyzer to capture the fax relay packets. A single fax call is placed to reproduce the problem, and then the information is captured from the attached devices for analysis. Figure: Test Equipment Placement shows where this test equipment is placed in the network.
