Guide Contents
Troubleshooting Cisco IOS Voice Overview
Debug Command Output on Cisco IOS Voice Gateways
Filtering Troubleshooting Output
Cisco VoIP Internal Error Codes
Troubleshooting Cisco IOS Voice Telephony
Troubleshooting Cisco IOS Voice Protocols
Troubleshooting Cisco IOS Telephony Applications
Monitoring the Cisco IOS Voice Network
Cause Codes and Debug Values

Cisco_IOS_Voice_Troubleshooting_and_Monitoring_--_Fax_Relay

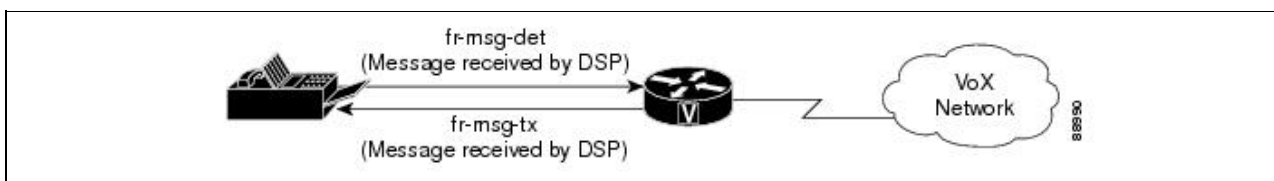
Figure: DSP Message Flow illustrates the directional flow of the DSP messages when the **debug fax relay t30 all** command is issued.

From the failed fax transaction shown in the debug above, you can see several badcyclic redundancy check (CRC) messages followed by a failure to train (FTT) message from the far side. From the debugs it looks like the problem involves the training signal. The bad crc errors and the FTT message returned from the other side indicate that the signal is corrupted or incompatible with the Cisco fax relay protocol. This debug is taken from a fax relay problem that occurs with a Lexmark Optra fax machine. The Lexmark is V.34-capable and attempts to connect at V.34 rates. V.34 is not supported in Cisco fax relay and the training errors shown here occur. See Cisco bug ID CSCdv89496 (registered customers only) for more details.
