Guide Contents
<u>Troubleshooting Cisco IOS Voice Overview</u>
<u>Debug Command Output on Cisco IOS Voice Gateways</u>
<u>Filtering Troubleshooting Output</u>
<u>Cisco VoIP Internal Error Codes</u>
<u>Troubleshooting Cisco IOS Voice Telephony</u>
<u>Troubleshooting Cisco IOS Voice Protocols</u>
<u>Troubleshooting Cisco IOS Telephony Applications</u>
<u>Monitoring the Cisco IOS Voice Network</u>
<u>Cause Codes and Debug Values</u>

- [1 Troubleshooting T.38 Fax Relay](#)
- [2 Identifying and Isolating the Problem](#)
- [3 Checking Basic Connectivity](#)
 - ◆ [3.1 Normal Voice Connectivity Problems](#)

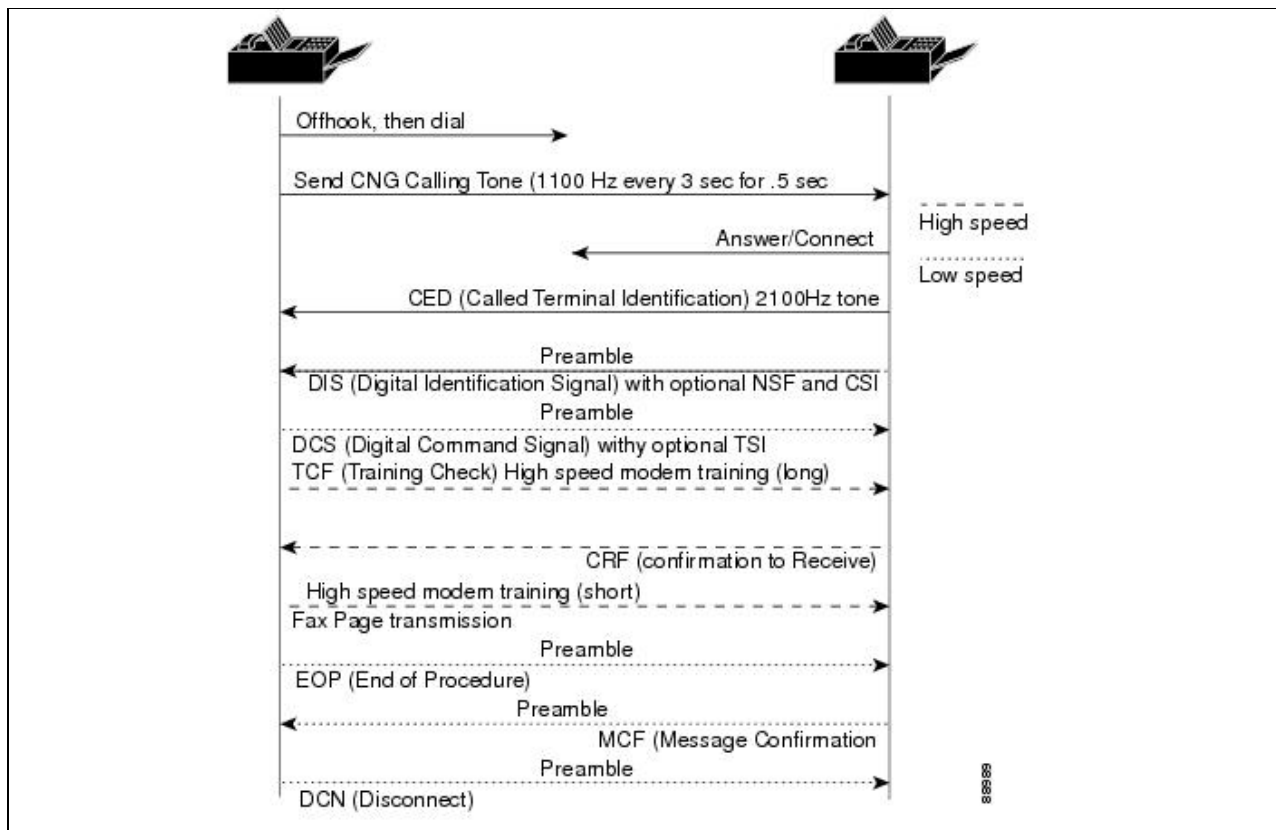
Figure: T.30 Transactions

The debugs can be difficult to understand if you are not familiar with the messaging that occurs during a typical fax transmission. [Figure: T.30 Transactions](#) is a graphical representation of the basic T.30 transactions that occur for a single page fax transmission.

Describing the details of these transactions is beyond the scope of this document, but listed below are definitions of the basic transactions that are seen during fax relay. The list is alphabetical for quick reference and includes messages that you are likely to see when you are debugging Cisco fax relay. For more in-depth information on this messaging or for information on messages that are not listed below, see the T.30 specification.

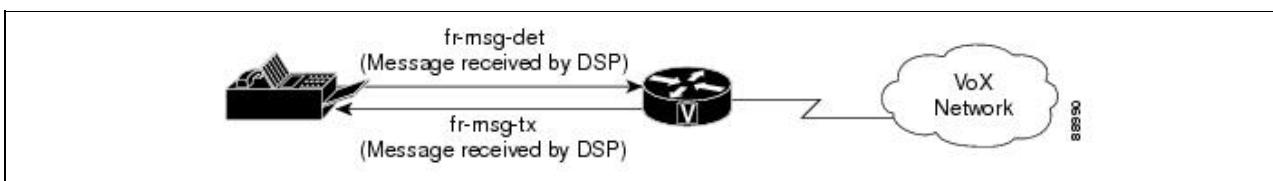
Figure: DSP Message Flow illustrates the directional flow of the DSP messages when the **debug fax relay t30 all** command is issued.

From the failed fax transaction shown in the debug above, you can see several badcyclic redundancy check (CRC) messages followed by a failure to train (FTT) message from the far side. From the debugs it looks like the problem involves the training signal. The bad crc errors and the FTT message returned from the other side indicate that the signal is corrupted or incompatible with the Cisco fax relay protocol. This debug is taken from a fax relay problem that occurs with a Lexmark Optra fax machine. The Lexmark is V.34-capable and attempts to connect at V.34 rates. V.34 is not supported in Cisco fax relay and the training errors shown here occur. See Cisco bug ID CSCdv89496 (registered customers only) for more details.
