This chapter explains how to upgrade cross-connect cards and optical spans (speeds) within a ring or protection group for the Cisco ONS 15454 SDH.

## NTP-D234 Upgrade the XC-VXL-2.5G Card to the XC-VXL-10G or XC-VXC-10G Card

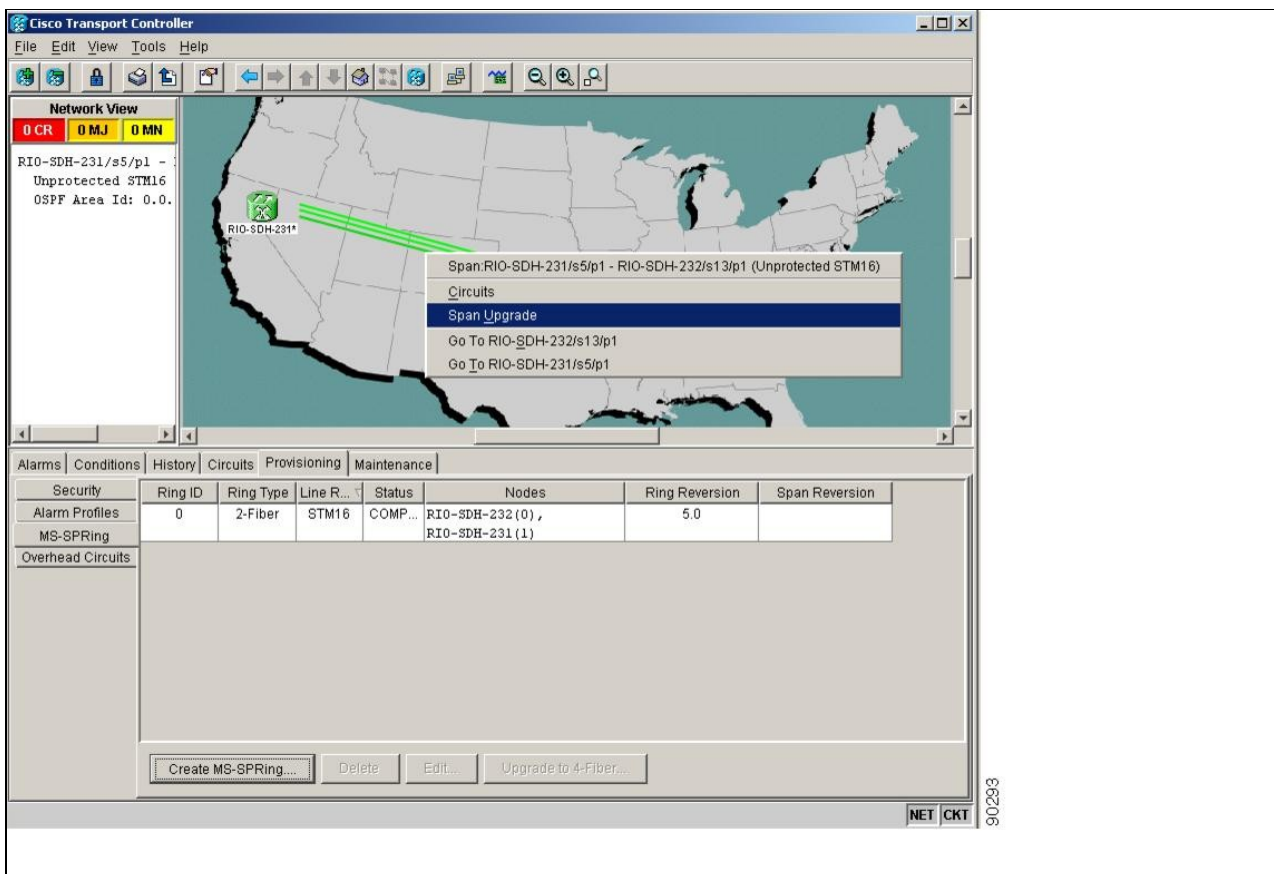
**Figure 12-1: Span Upgrade Shortcut Menu**

4. In network view, right-click the span you want to upgrade.
5. Choose **Span Upgrade** from the shortcut menu (Figure 12-1).

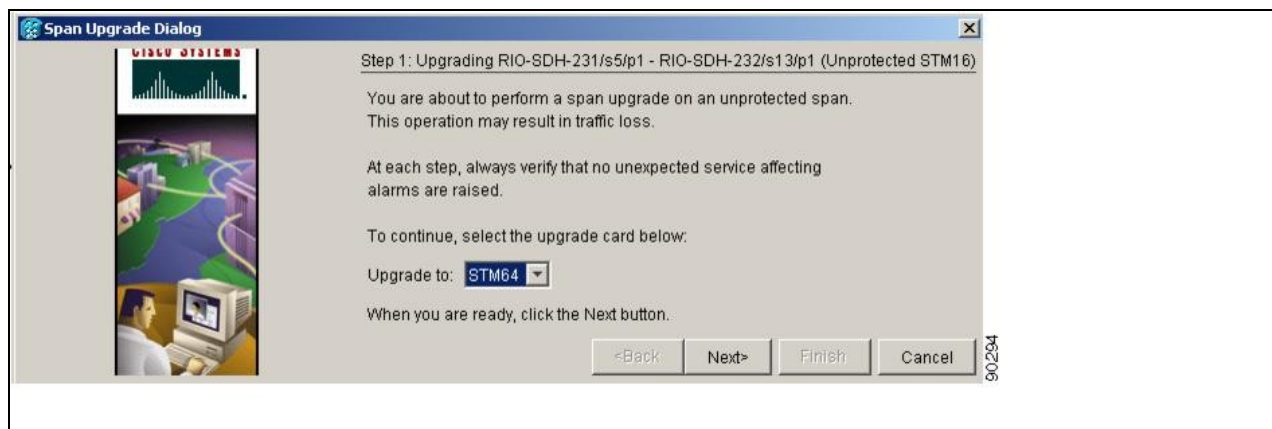
Figure 12-2: Span Upgrade Wizard

6. The first Span Upgrade dialog box appears (Figure 12-2). Follow the instructions in the dialog box and the wizard will lead you through the rest of the span upgrade.

**Note:** The Back button is only enabled on Step 2 of the wizard; because you cannot back out of an upgrade through the wizard, close the wizard and initiate the manual procedure if you need to back out of the upgrade at any point beyond Step 2.

**Caution!** As indicated by the wizard, when installing cards you must wait for the cards to boot up and become active before proceeding to the next step.
